**Application
for a
Certificate of Environmental Compatibility

Vulcan Interconnection Project**

**State of Arizona
Arizona Power Plant and Transmission Line Siting Committee**

Vulcan Solar Project, LLC

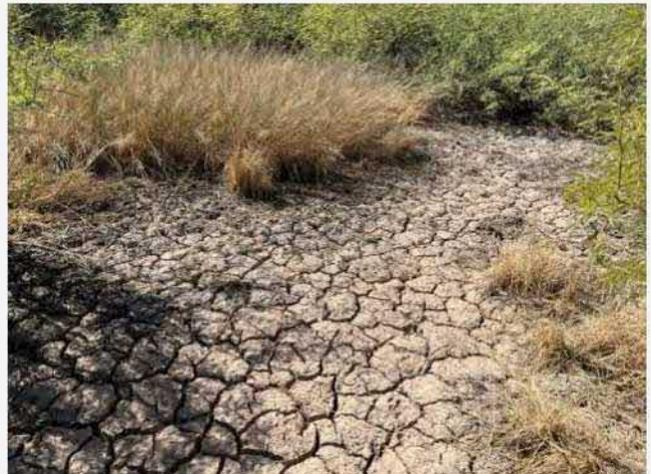
Photo 11. Hydrological indicator cracked soil within sampled area.

The sample point was taken in a concave depression area showing potential hydrologic indicators and change in vegetation (see Figure 6.5, Aquatic Resources). Hydrologic indicators included surface soil cracks and biotic crust, which are all primary hydrologic indicators in the arid west (see Photos 9–17 in Appendix B). During the October 2024 site visit, the depression was slightly saturated, with no surface water or water table present. NWI maps show that nearby features were anthropogenically created and that the area often floods, which is likely why hydrologic indicators are present. Historical aerial imagery shows that the area had last been cleared and tilled in 2014 (Google Earth 2024). Hydrophytic vegetation was not found during this delineation.

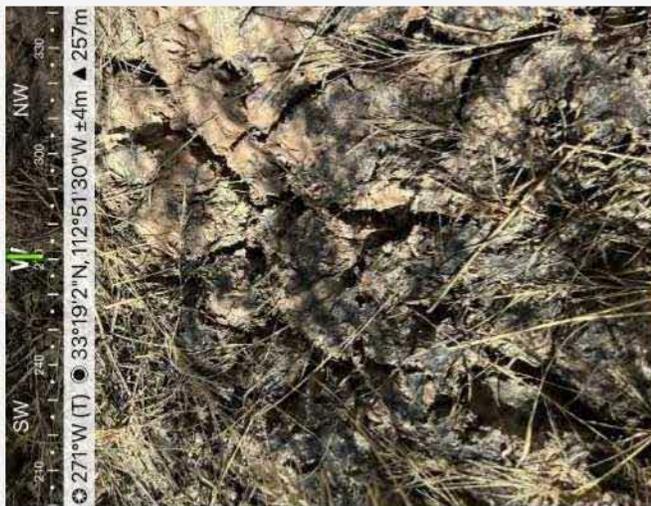
Photo 12. Hydrological indicator biotic crust within sampled area.

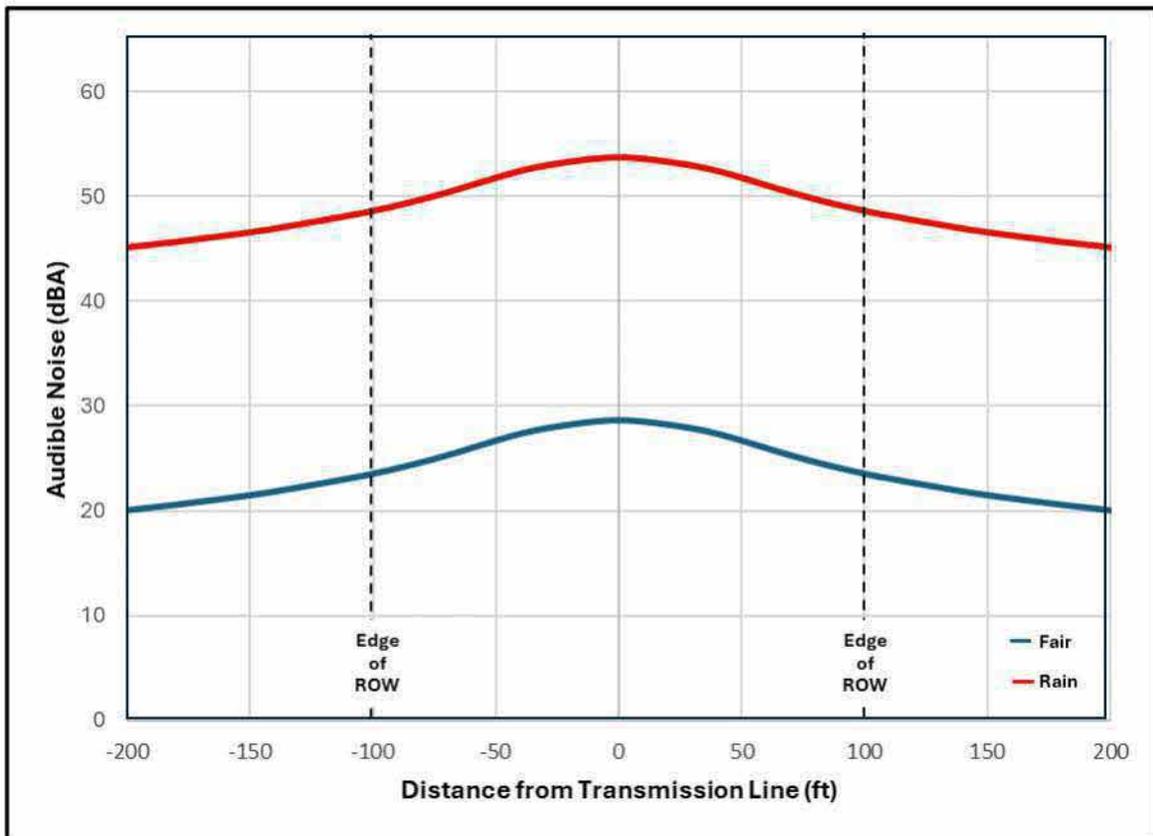
Figure I-1. Corona Audible Noise for a 500 kV Transmission Line

The results from the 500-kV Boardman to Hemingway Transmission Line Project showed various noise levels under different weather conditions, as shown in **Figure I-1**. Under fair weather conditions, the noise at the ROW edges was approximately 23 dBA, while in wet conditions, it increased to 48 dBA. The maximum noise observed within the ROW was 22 dBA in fair weather and surged to 53 dBA during wet conditions. For the closest residential receptors, approximately 2.3 miles east and west of the Study Area, and not accounting for the differences in elevation, corona noise during normal operations either would be indistinguishable from ambient sounds or inaudible, depending on the final siting of the gen-tie line.
